EGT Exceedence And Its Effect On Turbine Components 3

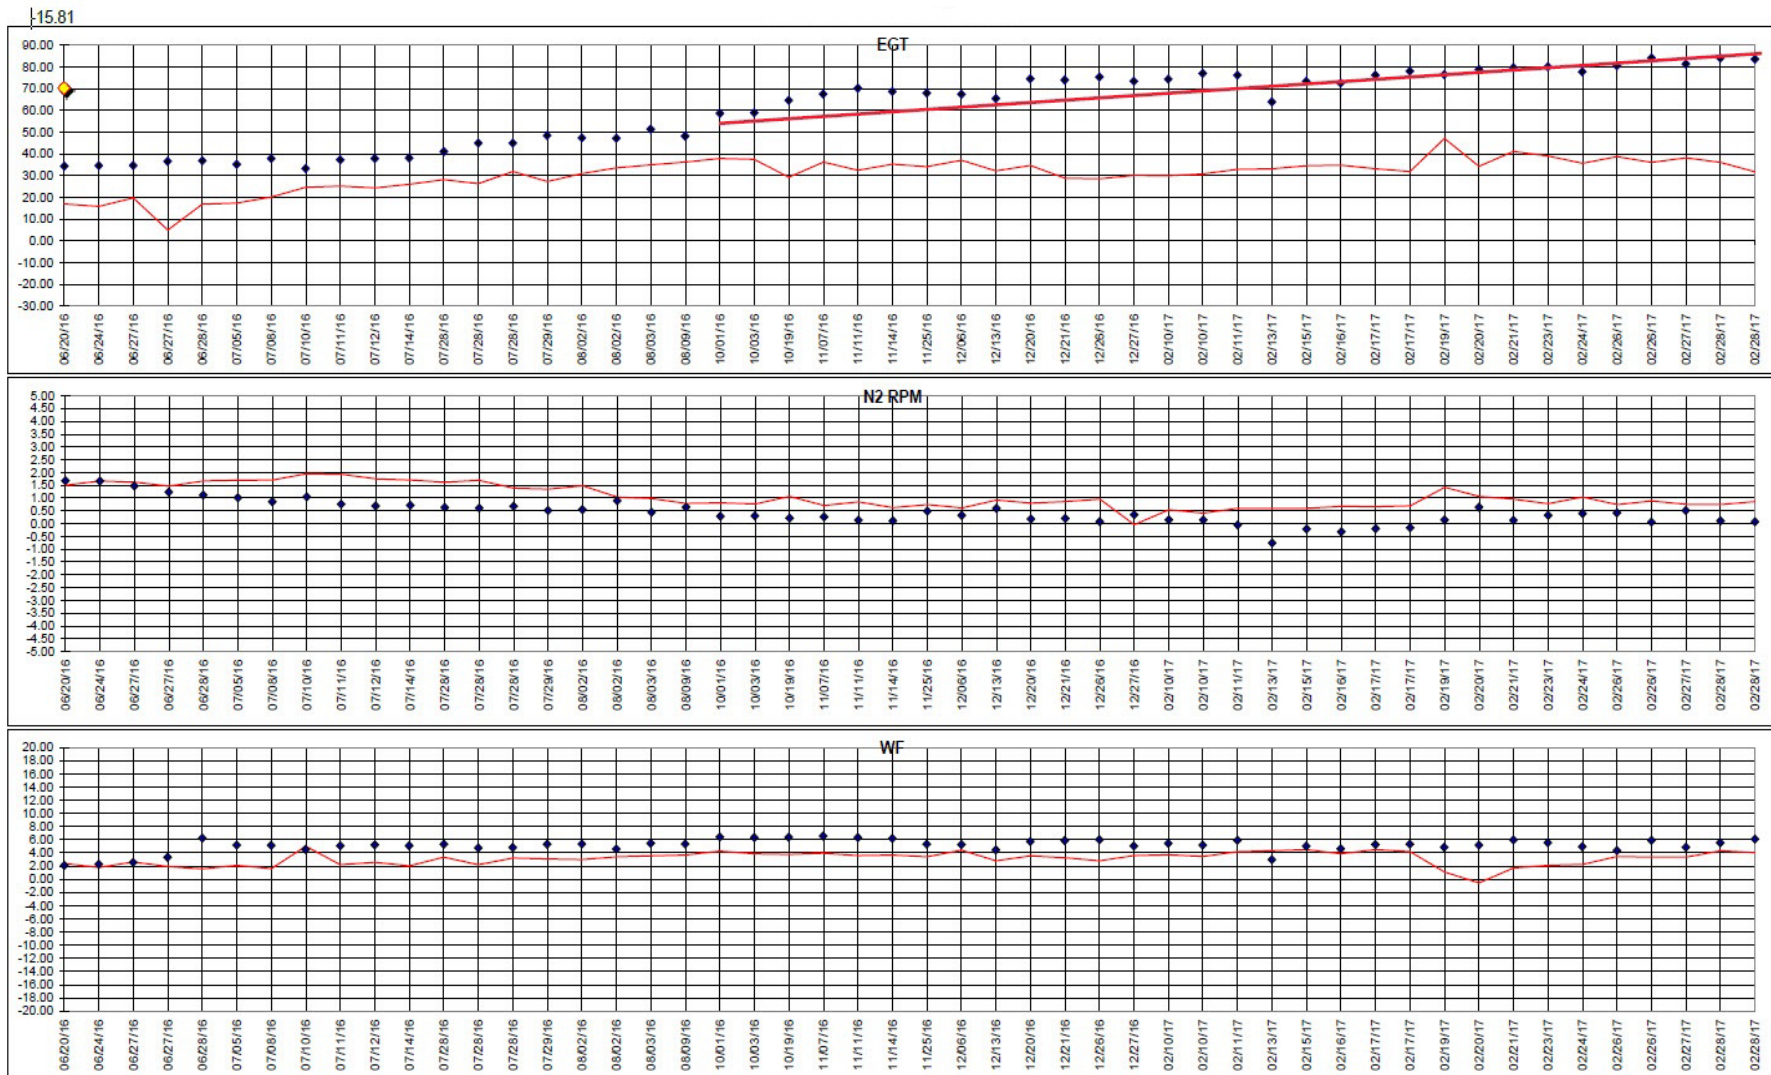
EGT trend has reached the top of the charted area and it is still on an increasing slope. The Aircraft has been eliminated by the engine swap, the continuing increase in EGT indicates the problem is internal gas path and not indication. Immediate action to trouble shoot, determine cause and repair is highly recommended. If the engine Turbine components are actually being subject to the high temperature Turbine Failure is imminent.
