## EGT Decrease From An Engine Swap

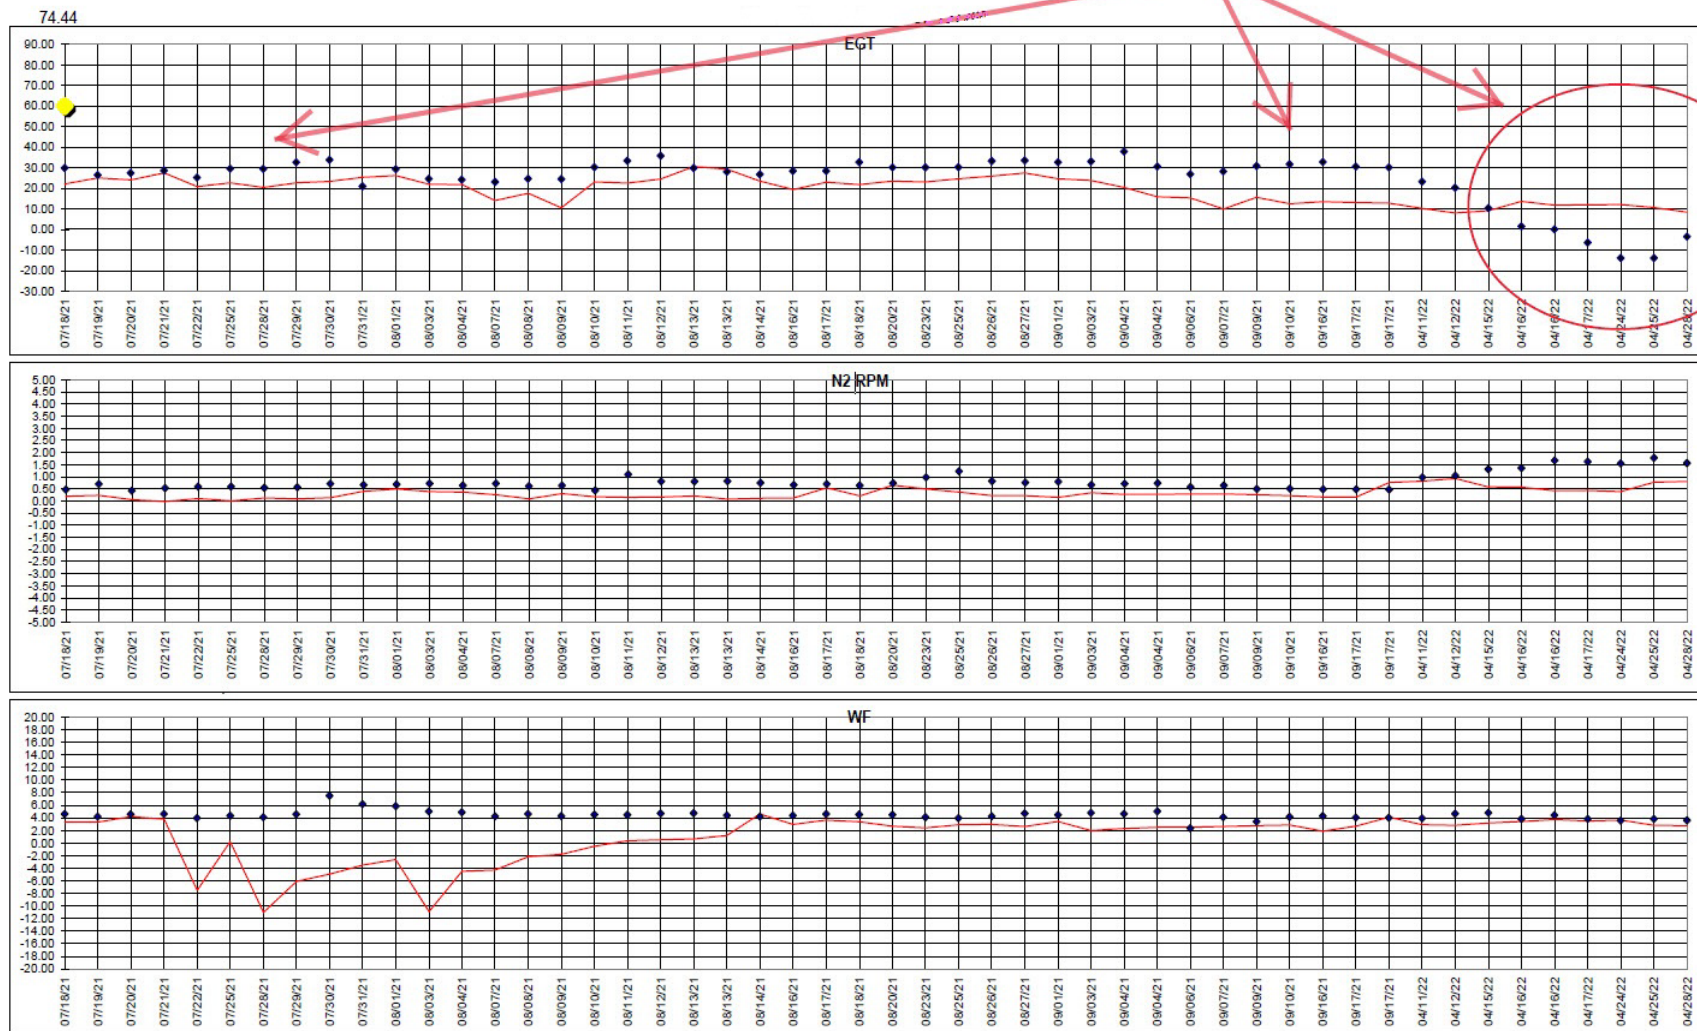
The EGT system on this aircraft requires troubleshooting to understand and correct the cause of the lower shift noted in the EGT indicating system when the engine was installed on a different aircraft. The problem created by this shift is it places doubt on the accuracy of the EGT indicating system and the ability of the flight crews to identify overtemperature events.
