## Vibration Illustration 1

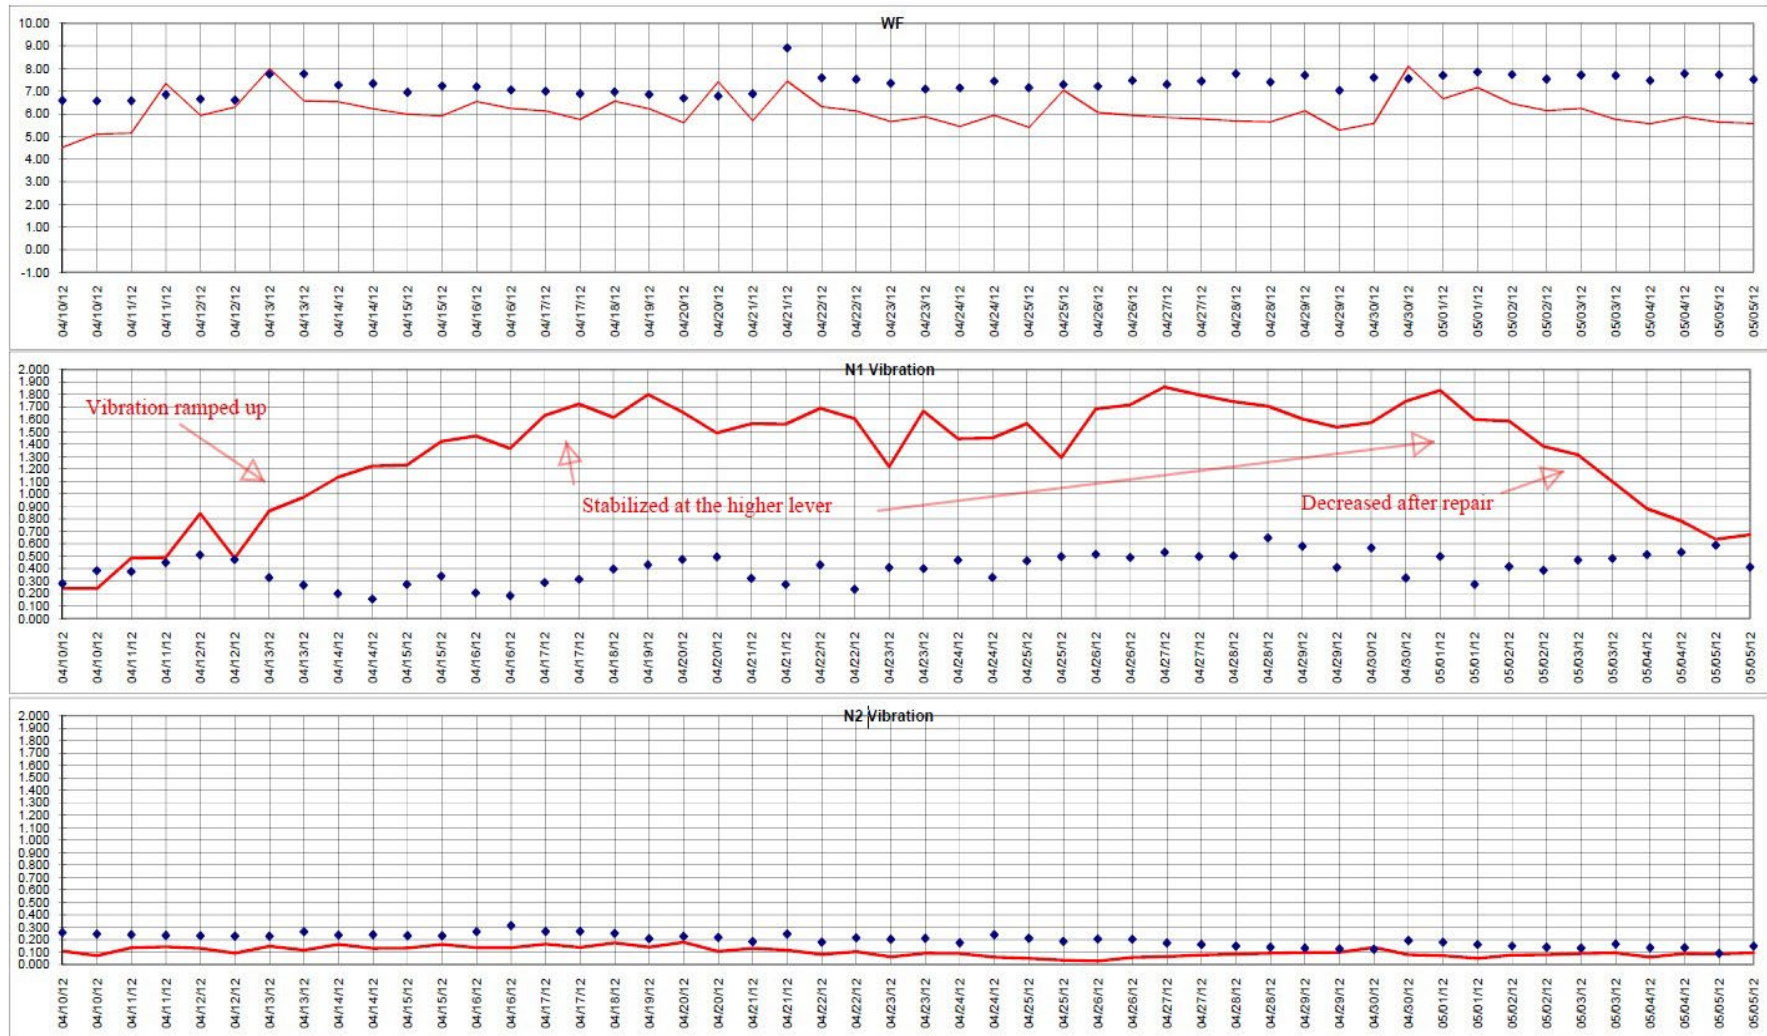
Case of N1 Vibration caused by Fan Blade lock up. Although the vibration trend was significant the vibration level was well below the AMM recommended guidelines. The Engine operated until a scheduled check where the Fan Blades were removed, lubricated and installed.
