## Vibration Illustration 2

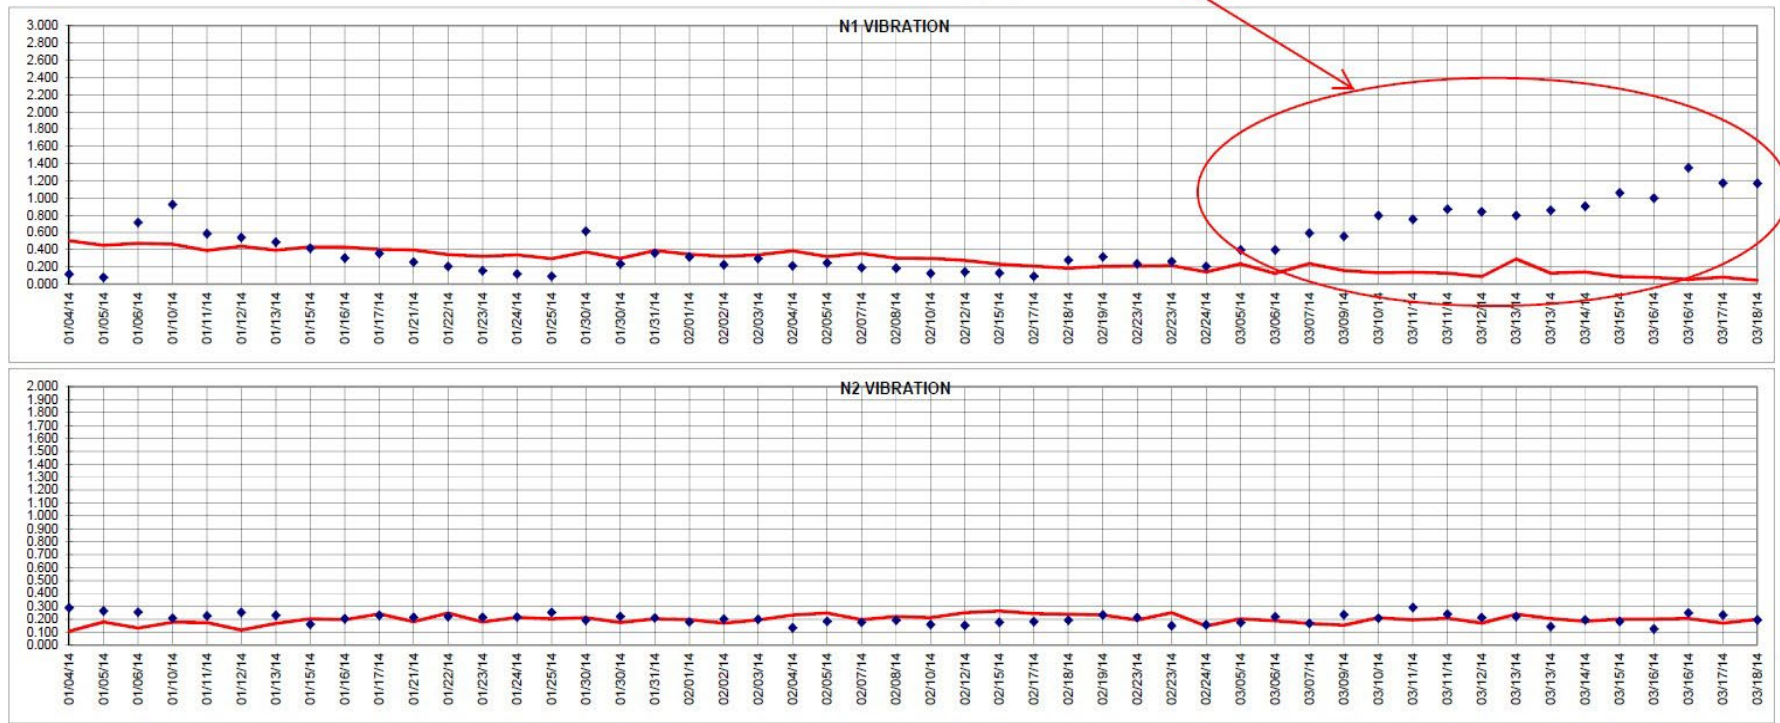
N1 Vibration has increased but is still within the guidelines.  
However the fan blade annulus fillers seals should be checked  
to be sure they are all seated and the , fan blades inspected for  
damage
